Narbrook Park East Branch Indian Creek

Existing Conditions / Site Analysis

Julie A. Snell ISA, AOLCP Principal, TEND landscape inc.

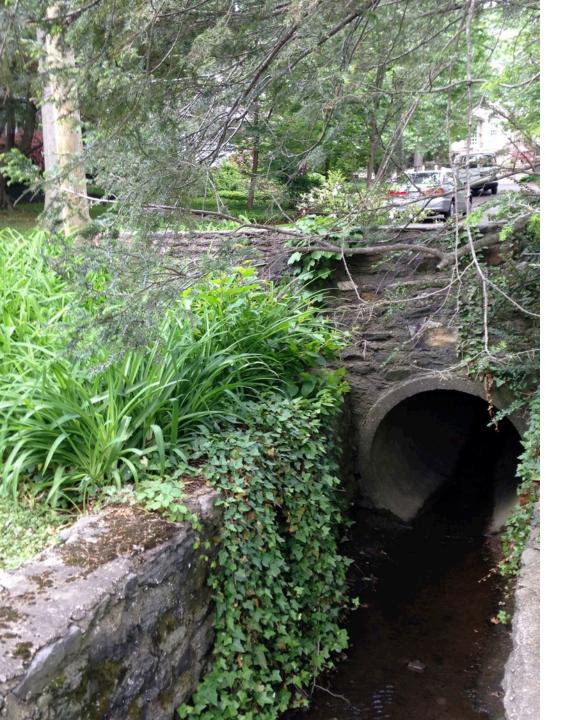
Piped and Channelized creek

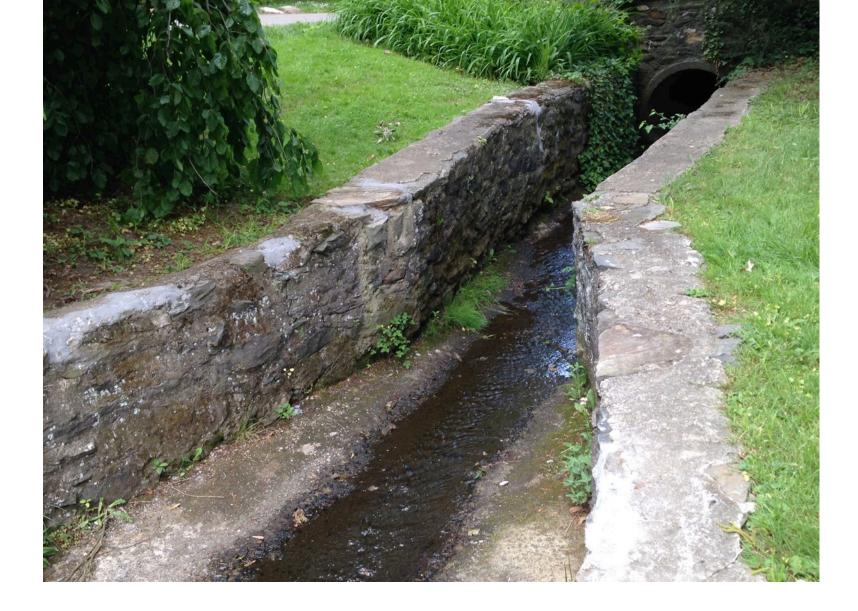
Constricted flow increases velocity

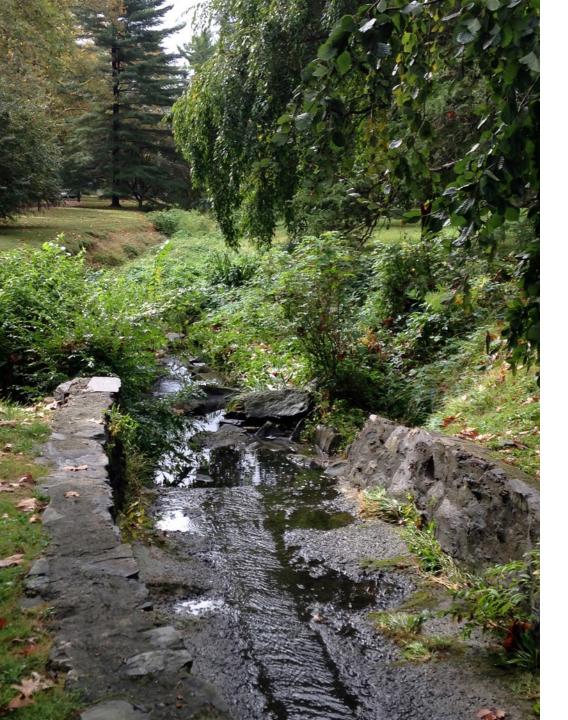
Erosion at the end of the channel

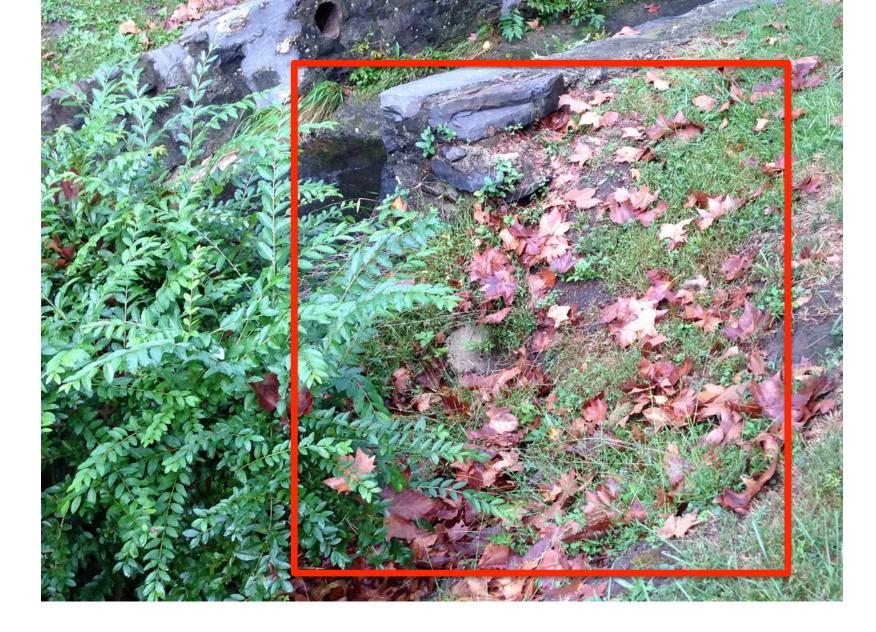
Eroded bank at end of channel wall

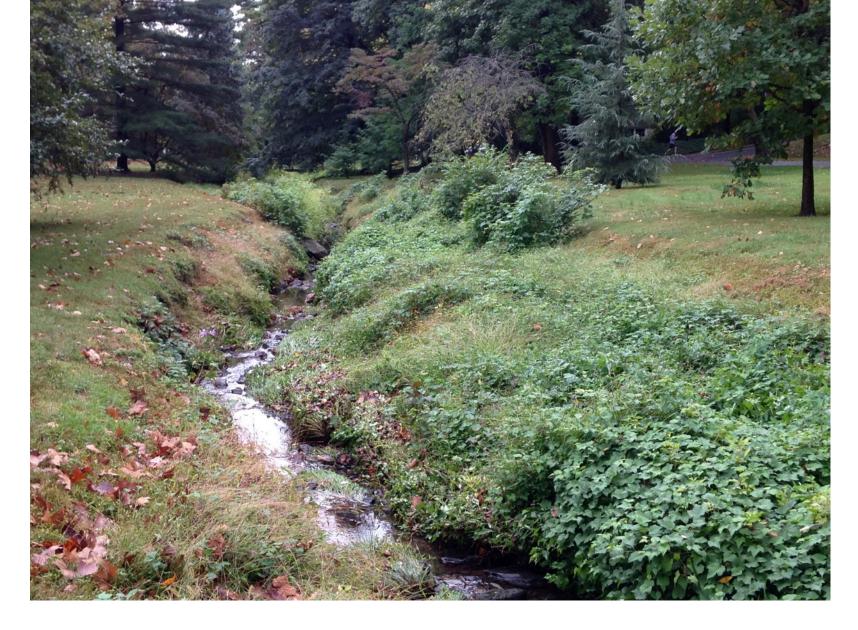
Scoured and eroded banks Invasive species flourish

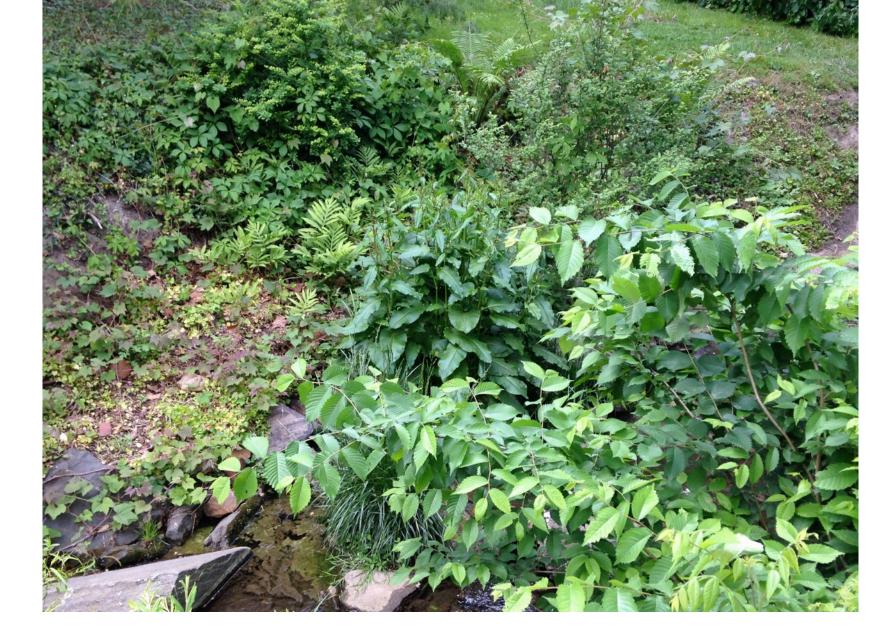
Invasive plants

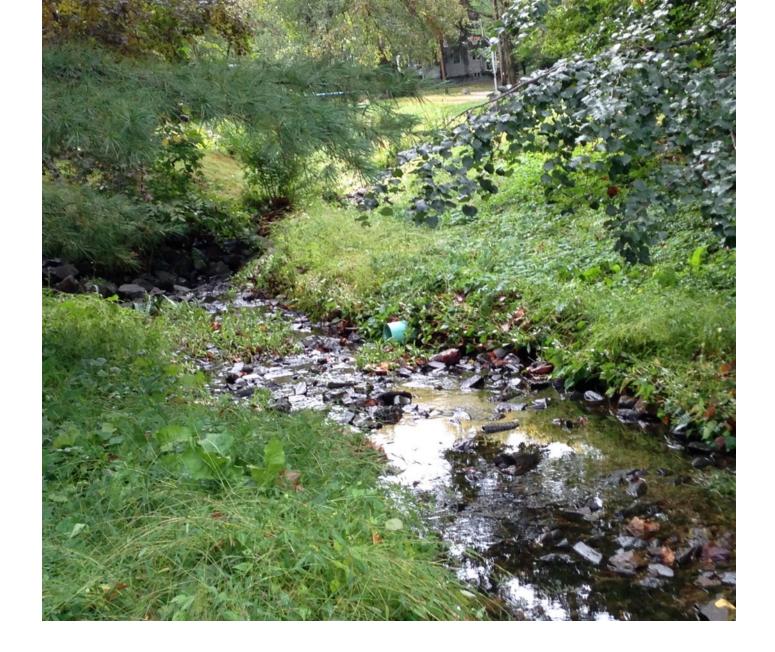
Street runoff piped directly into stream

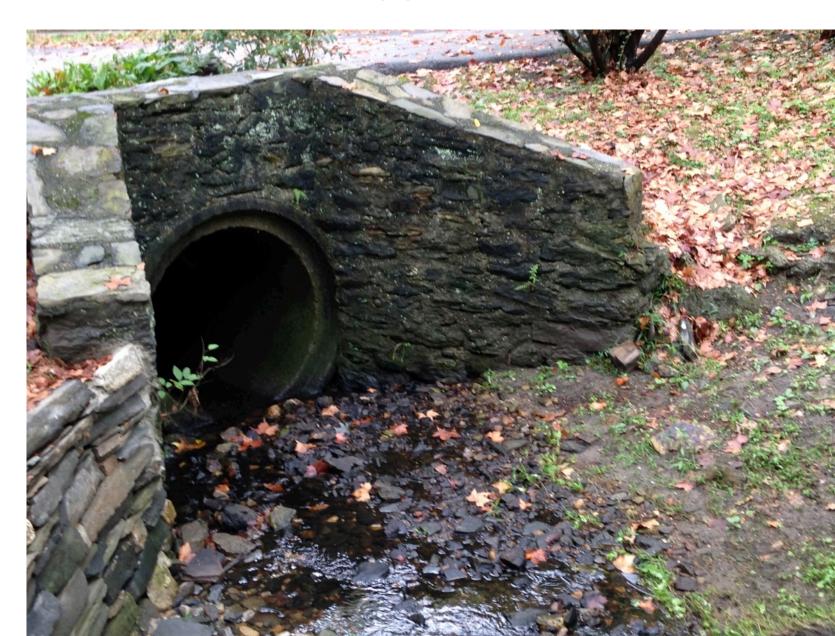
Creek re-enters pipe and channel on south end

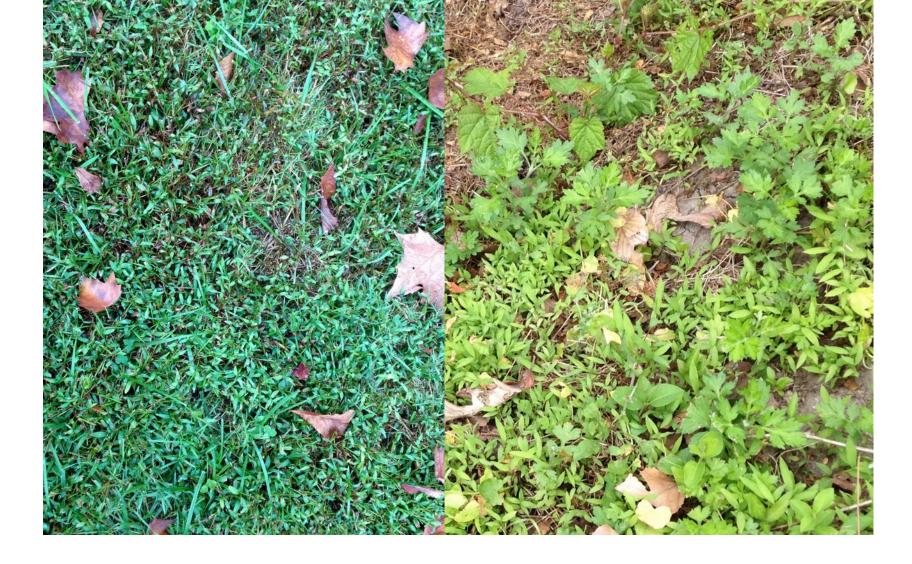
Condition of lawn varies

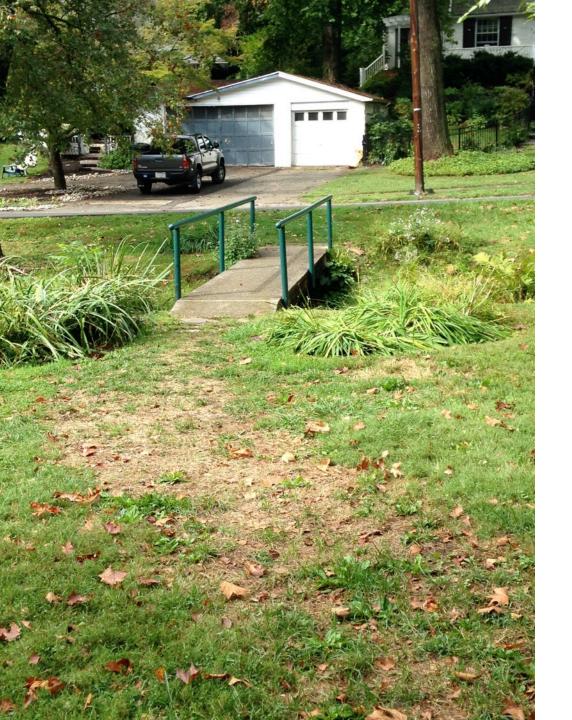
Worn and compacted from foot traffic

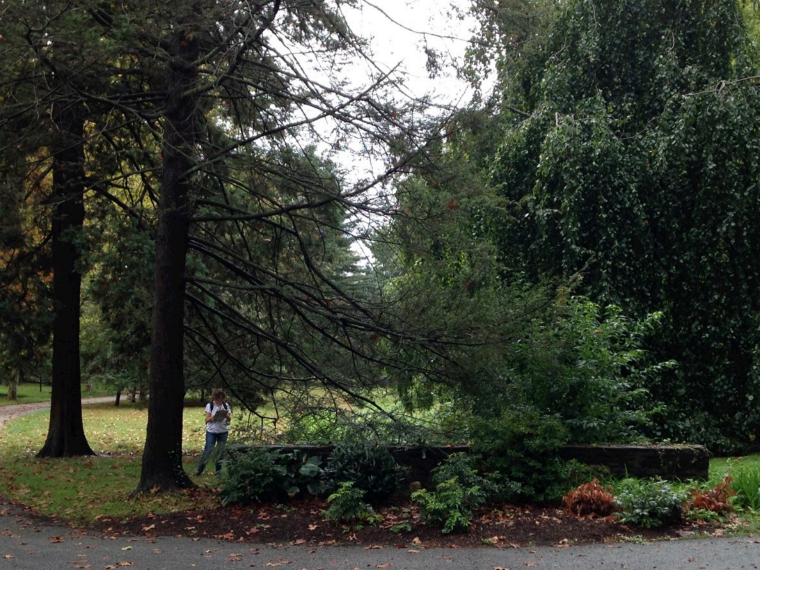
View from north entrance blocked by declining hemlock
