Evaluating the influence of lawn care practices on the headwaters of a suburban watershed

**Steven T. Goldsmith, PhD
Department of Geography and the Environment
Villanova University**

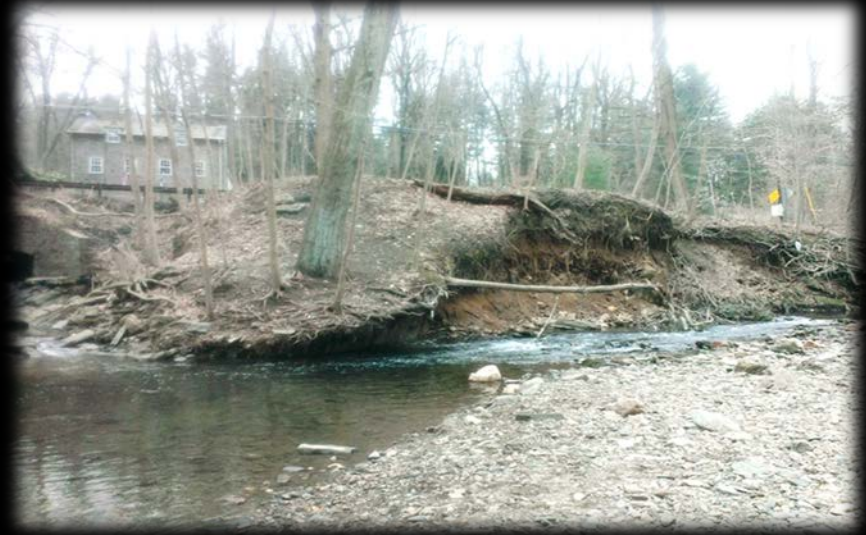
West Mill Creek Park,
Lower Merion Township,
PA

- Increased downstream bank erosion and stream turbidity

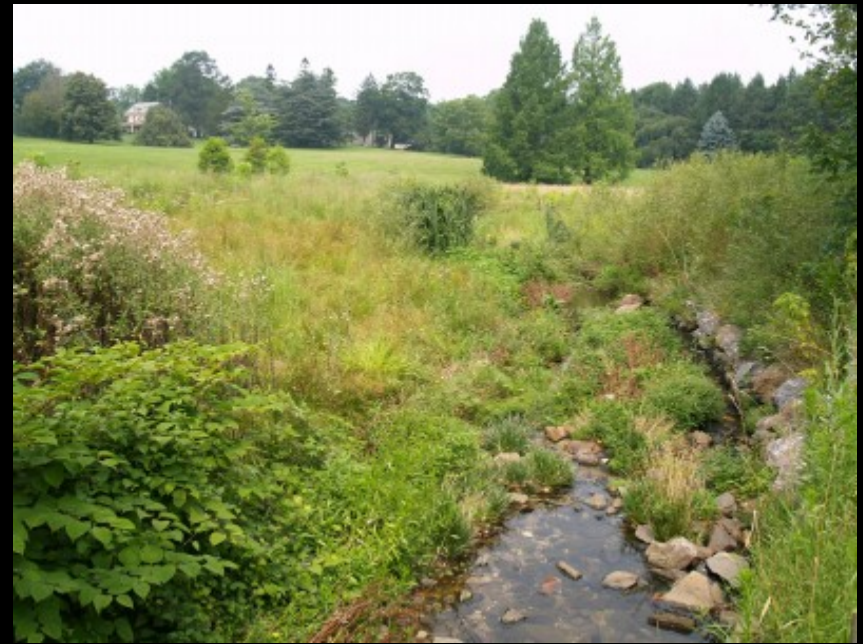
Ashbridge Memorial Park
Credit: LMC

- Limited amount of Narbrook park residents apply fertilizer
- Introduction of a riparian buffer would likely improve stream quality (Sweeney and Newbold, 2014)
